From: Jonathan Gillen <JGillen@geosyntec.com>
Date: Fri, Nov 2, 2018 at 1:13 PM
Subject: Stratus Redtail 2 Property: Limited Phase II subsurface investigation daily field report (11/1)
To: Stovall - CDPHE, Curtis <curtis.stovall@state.co.us>
Cc: Richard Dean <rdean@stratuscompanies.com>, Jonathan H. Steeler <JSteeler@sennlaw.com>, Dave Folkes <DFolkes@geosyntec.com>, Luke Fitzgerald <LFitzgerald@geosyntec.com>, Martina Litasi <MLitasi@geosyntec.com>

DATE:	November 1, 2018
WEATHER:	Cloudy, sunny, afternoon winds, H 62 °F; L 33 °F (Weather info obtained from Vista Ridge - Alpine Station – Weather underground)
WORK START/END:	November 1, 2018 (8:00 am – 4:25 pm MDT)
Activities Summary:	Test pit excavations
Geosyntec Personnel on-site:	Luke Fitzgerald
Subcontractor Personnel on-site:	Chad Gibbs (Overley's), Angel Cardenas (Overley's), Nestor Sapien (Overley's), Curt Stovall (CDPHE)
Attachments:	Field Test Pit Logs for: TP-EM-05, TP-EM-04, TP-EM-06, TP-EM-03, TP-EM-02, TP-EM-01, and TP- ESW-01.

INVESTIGATION ACTIVITY SUMMARY

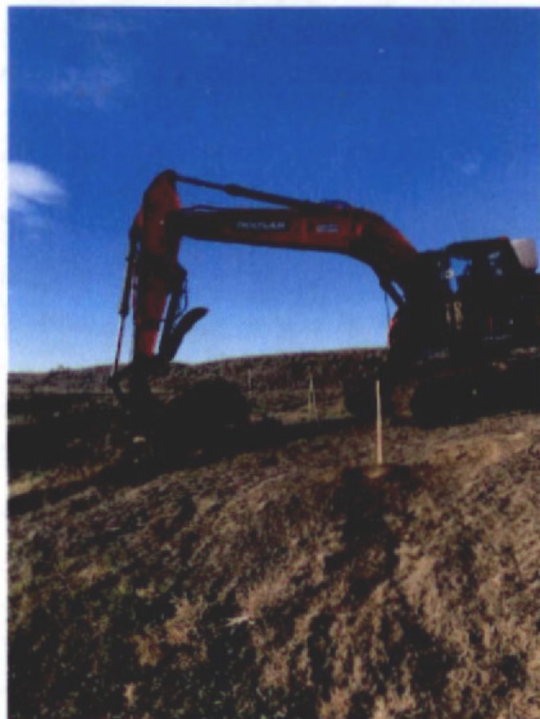
Figure 1: Overley's utilizes a Doosan DX235LCR excavator to excavate test pit TP-EM-05.

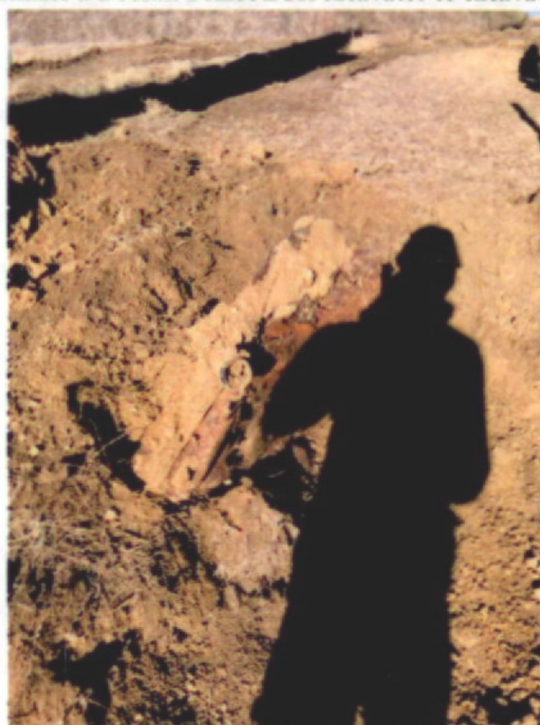
- Overley's began excavation at TP-EM-05 at 8:55 am. A single piece of metal, suspected to be a gas tank from a vehicle was identified approximately 1 ft below ground surface (bgs). Additional material was excavated around the identified anomaly to verify that no additional metallic debris was located in the area.

Figure 2: Metallic anomaly identified in TP-EM-05.

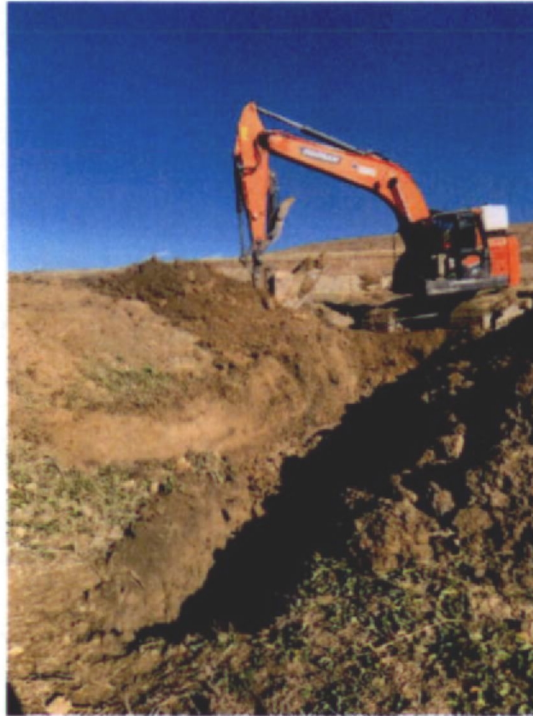
Figure 3: Excavating at TP-EM-04.

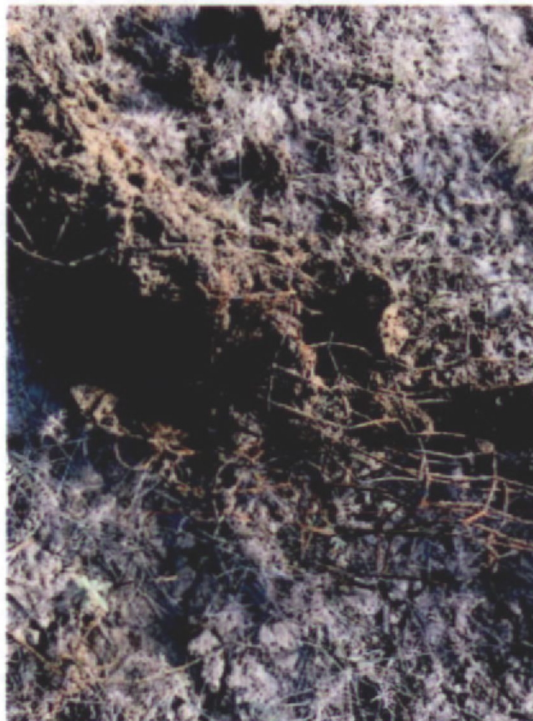
- Overley's began excavation at TP-EM-04 at 9:30 am. Multiple pieces of metal including suspected springs and mattress components were identified approximately 1-2 ft bgs. Additional material was excavated around the identified anomalies to verify that no additional metallic debris was located in the area.

- Based on discussions with CDPHE additional material in the area of the TP-EM-04 anomaly was excavated to further investigate the full extents of the anomaly, as identified on Figure 1 of the Waste Connections Property – Limited Phase II Environmental Site Assessment Scope of Work (SOW), additional fragments of metallic debris were found scattered through area. Areas were excavated to depths down to native/undisturbed material.

Figure 4: Metallic debris from TP-EM-04.

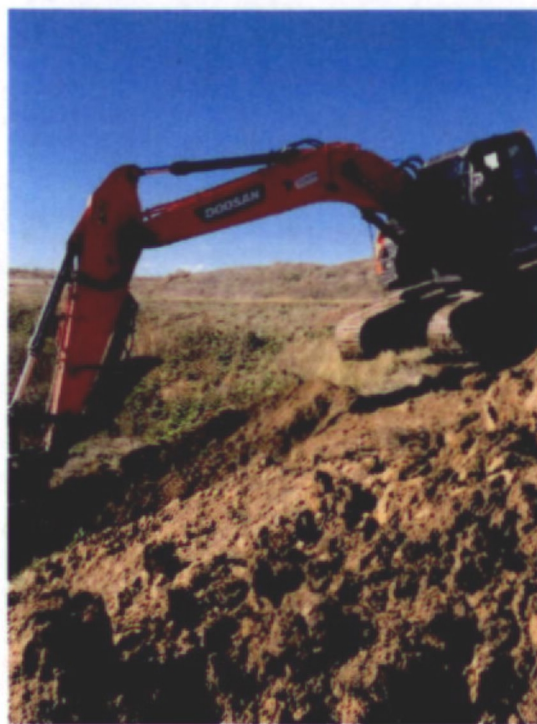
Figure 5: Excavating at TP-ME-06.

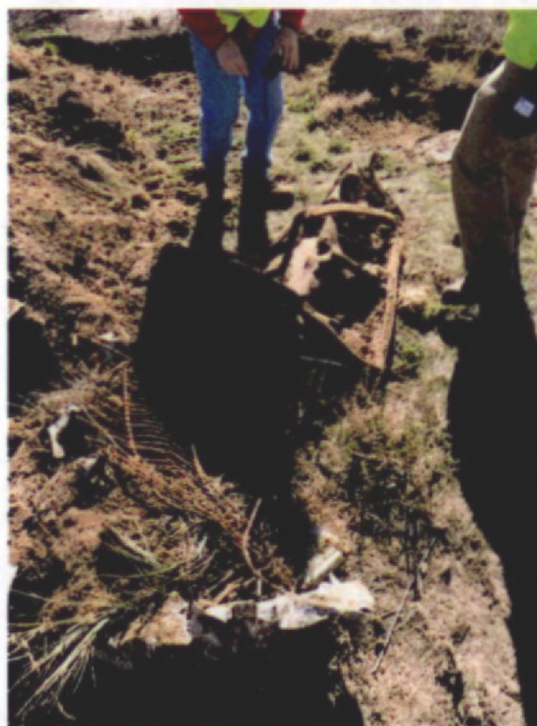
- Overley's began excavation at TP-EM-06 at 10:20 am. Multiple pieces of metal suspected to be from a refrigerator were identified approximately 1 ft bgs. Additional material was excavated around the identified anomaly to verify that no additional metallic debris was located in the area.

Figure 6: Metallic debris from TP-EM-06

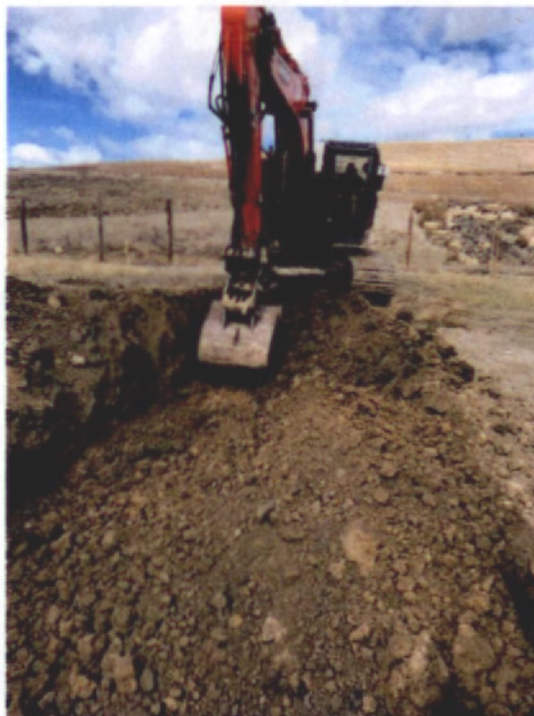
Figure 7: Excavating at TP-EM-03.

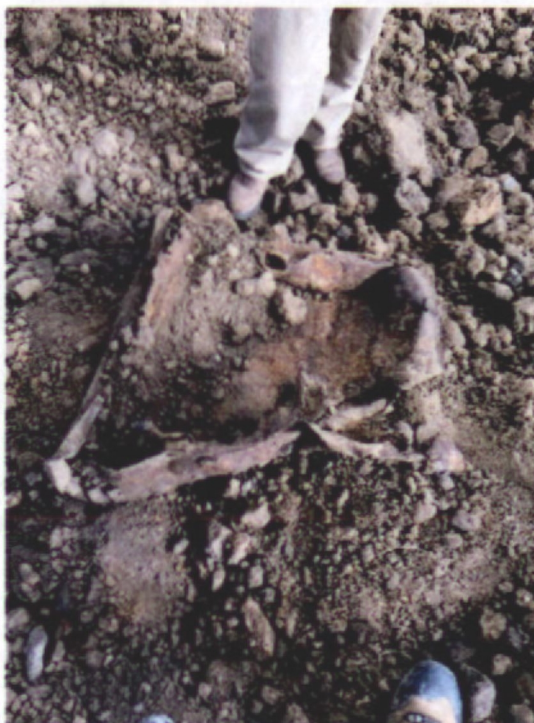
- After reevaluating the location for TP-EM-03, Overley's began re-excavation of the location at 12:25 pm. A single piece of metal, suspected to be a gas tank from a vehicle was identified approximately 2 ft bgs. Additional material was excavated around the identified anomaly to verify that no additional metallic debris was located in the area.

Figure 8: Metallic debris from TP-EM-03.

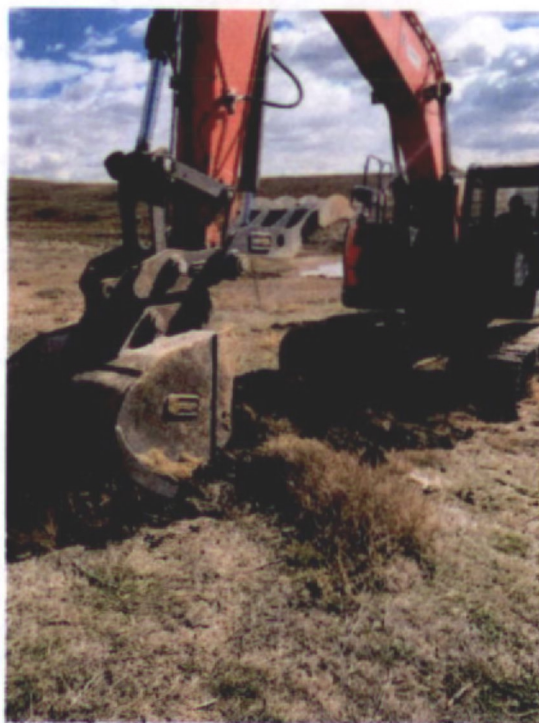
Figure 9: Excavating at TP-ME-02.

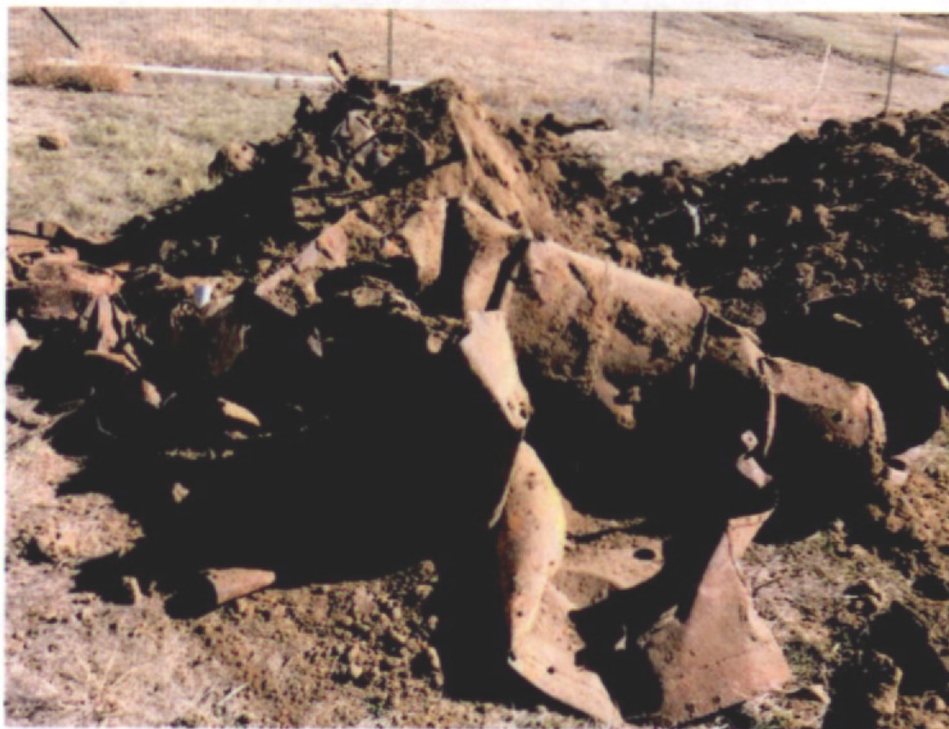
- Overley's began excavation at TP-EM-02 at 1:15 pm. Multiple pieces of metal, suspected to be pieces from one or multiple vehicles, were identified approximately 1 ft bgs. Additional pieces of metallic debris were excavated but could not be identified. Additional material was excavated around the identified anomaly to verify that no additional metallic debris was located in the area.

Figure 10: Metallic debris from TP-EM-02.

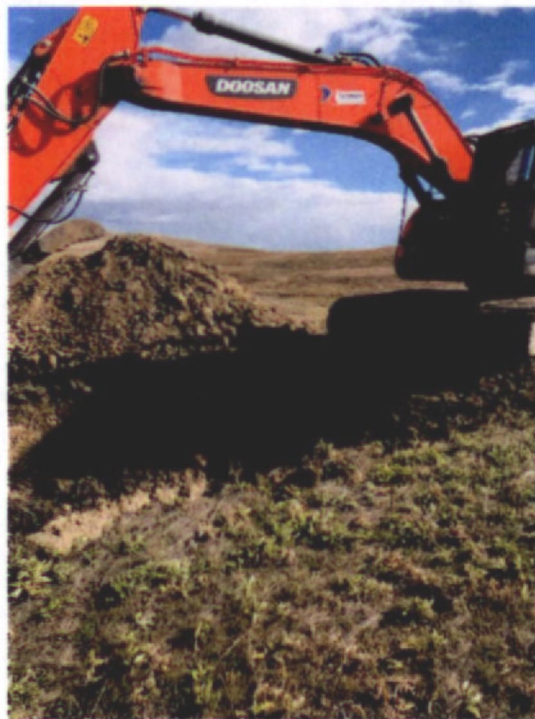
Figure 11: Excavating at TP-ME-01.

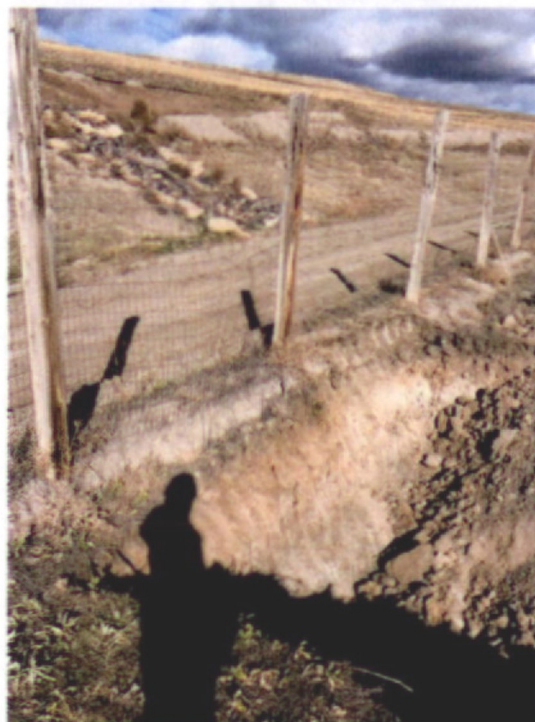
- Overley's began excavation at TP-EM-01 at 3:40 pm. No metallic anomalies were identified in the location identified on Figure 1 of the SOW, the excavation was extended to a depth below native/undisturbed material to confirm that no buried metallic objects were in the area. A section of fence along the Northern boundary of the Site that was deformed in the direction of the anomaly identified on Figure 1 of the SOW was thought to possibly be the source of the anomaly identified in the area. Excavations were extended approximately 650 ft to the south to the starting location of TP-ESW-01 to identify the ESW. No solid waste or metallic

Figure 12: No metallic anomaly identified in TP-EM-01 up to edge of property fence.

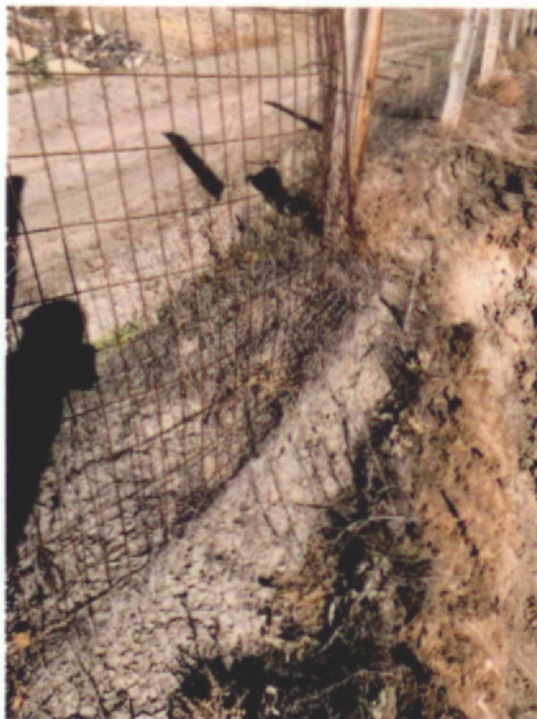
Figure 13: deformation in fence possibly responsible for anomaly originally identified at TP-EM-01.

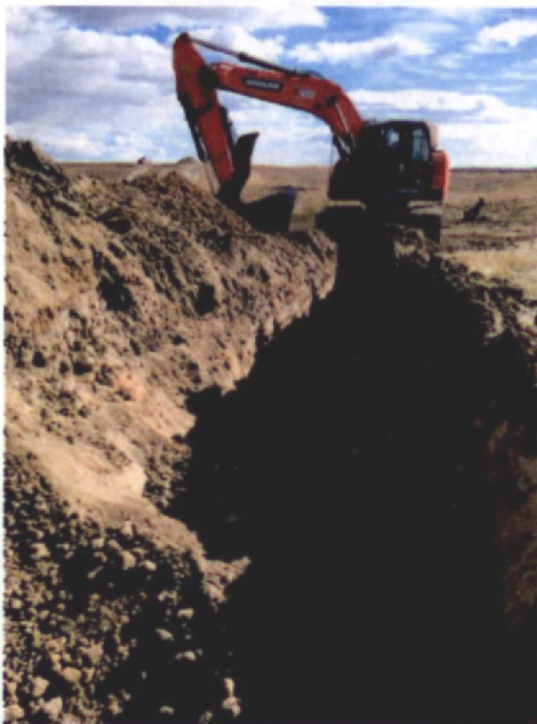
Figure 14: Excavation at TP-EM-01 extended to the south to E-W line of TP-ESW-01 location.

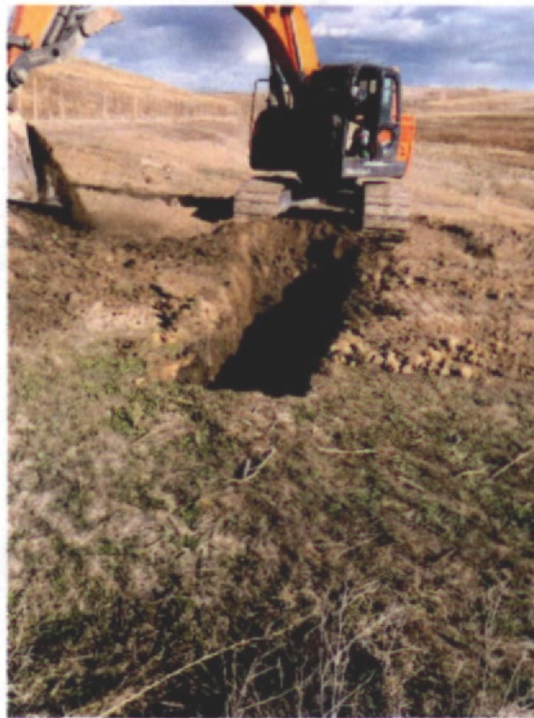
Figure 15: Excavating at TP-ESW-01.

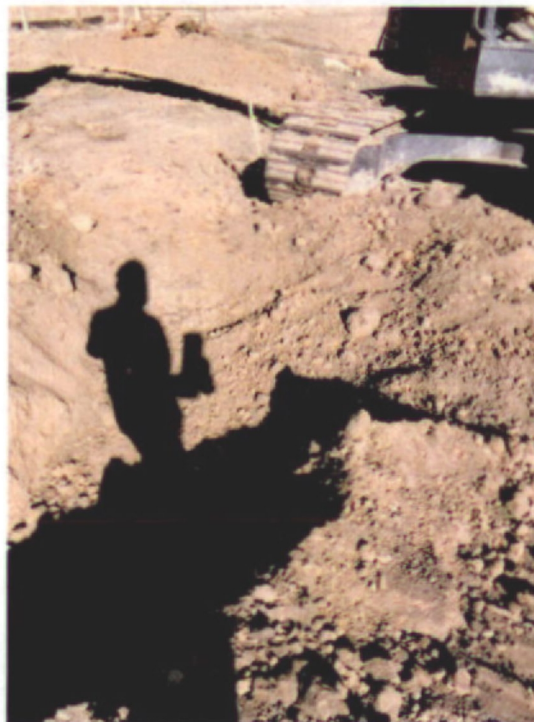
- Overlay's began excavation at TP-ESW-01 at 3:20 pm. At 3:25 pm two members of the Overlay's crew demobilized from the site for the day. The excavation was extended to the east approximately 35 ft, until the location of the previous excavation and magnetic anomaly from TP-EM-03 was encountered. As solid waste was found in this location it was deemed to be the edge of solid waste for the location. Final excavation at TP-ESW-01 was approximately 35 ft L x 4 ft W x 4 ft D.
- At 3:55 pm, Geosyntec mobilized to location of monitoring wells on-site. Chad from Overleys performed maintenance on the excavator.
- At 4:00 pm, Geosyntec collected water levels from the four new on-site monitoring wells.
- At 4:20 pm, Overlay's demobilized from the site for the day.
- At 4:25 pm, Geosyntec demobilized from site for the day.

Figure 16: Excavation at TP-ESW-01 extended to test pit excavation for TP-EM-03.
